Learning from Earthquakes

The March 20, 2012, Ometepec, Mexico, Earthquake

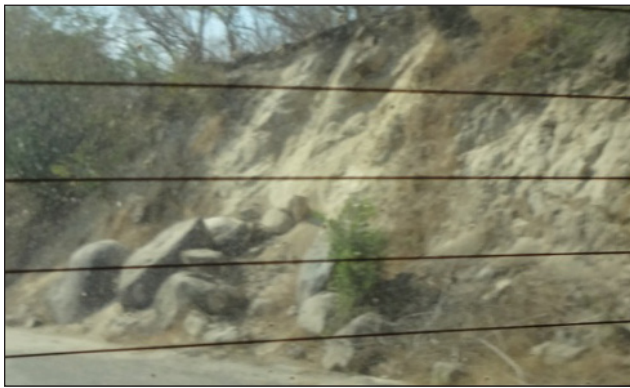
Figure 3. Small debris fall on Ometepec-Huajintepec Road.

On the road between Copala and Ometepec, approximately 10 km southwest of Ometepec, we observed minor landslides. On the roads around the epicenter area there were no slides (rotational or translational), lateral spreads, or in roads, but very small debris falls or debris topples were detected in short and large road cuts (Figure 3).

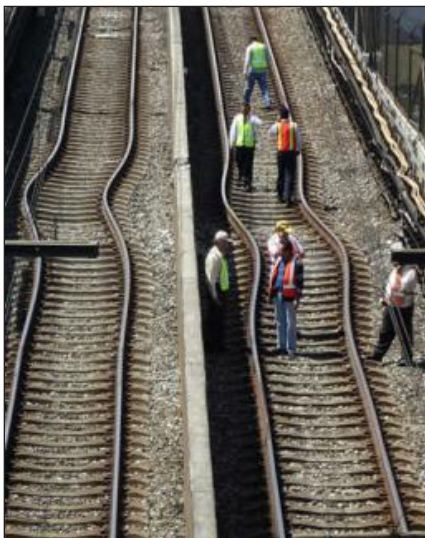
The SAS earthquake warnings gave 60 seconds to the Metro system to stop operations, and also gave operators and people time to evacuate. No damage or injuries were accounted for, although Line A of the Metro station sustained damage to the rail structures, probably due to presence of large surface waves (Figure 6). However, 24 hours later, line A was repaired and fully functional.

Figure 6. Damage to Metro's rail system (source: Twitter, user Adan4xinhua?).

In Mexico City, most damage occurred to the transportation system. Line A of the metro sustained damage to its rails (Figure 6). Damage to the supporting system of a motor

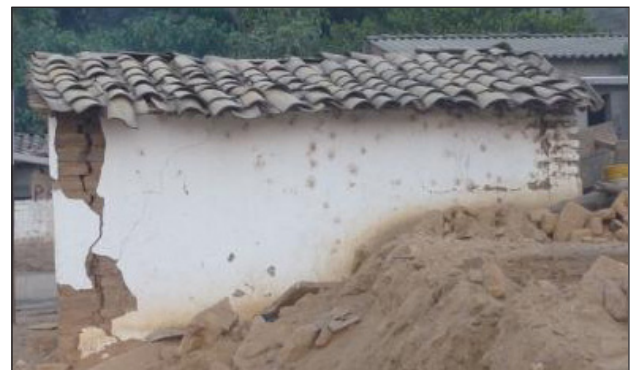
with no lateral resistant elements. As was the case in 1995 (Sordo et al., 1995), adobe quality again played a key role in structural response: major damage was observed in weathered adobe blocks. Rain and other natural elements degrade the resistance and stiffness of adobe blocks. Three typical failures were detected: (1) inadequate bonding in the adobe wall corners led to out-of-plane failures (Figure 7); (2) transverse wall failure due to inertial forces induced by the main wooden beam of the roof system; and (3) stress concentrations at corners of openings in the walls (windows and doors).

Figure 7. Out-of-plane failure in adobe walls due to inadequate bonding.

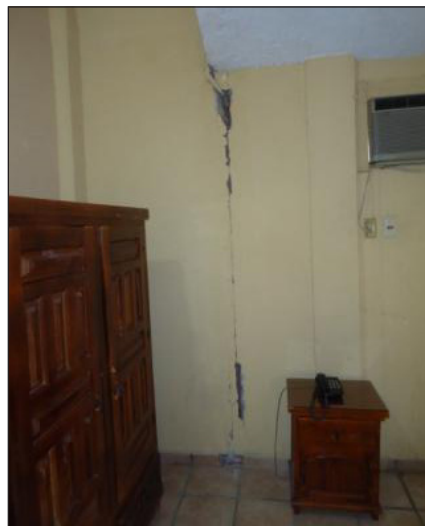
Figure 10. Cracking at the constructive joints and in infill masonry walls.

A two-story concrete and masonry hotel in Ometepec has a great wall density ratio, an irregular structural configuration, and inadequate constructive

joints, so cracking was visible in several infill masonry walls and in places where the constructive joints were located (Figure 10).

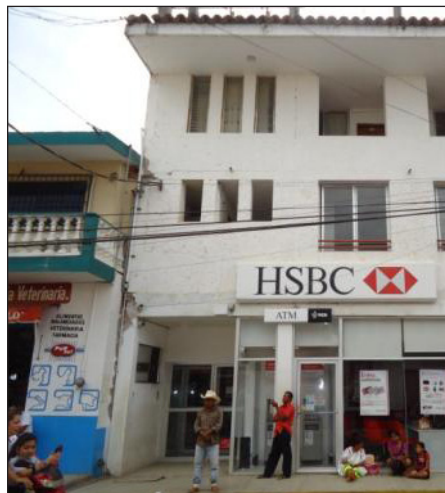
A three-story concrete hotel with masonry infill walls also sustained light to moderate structural damage in the concrete frame. It was evident that the separation from neighboring buildings

was inadequate and was filled up with rocks and stones; this led to pounding, causing damage at the joints of the beams and columns (Figure 11).

Figure 11a ▲ and b. Pounding and cracking in beam elements. ►

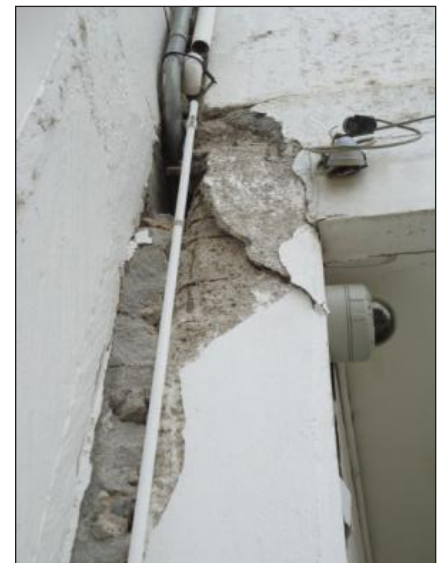
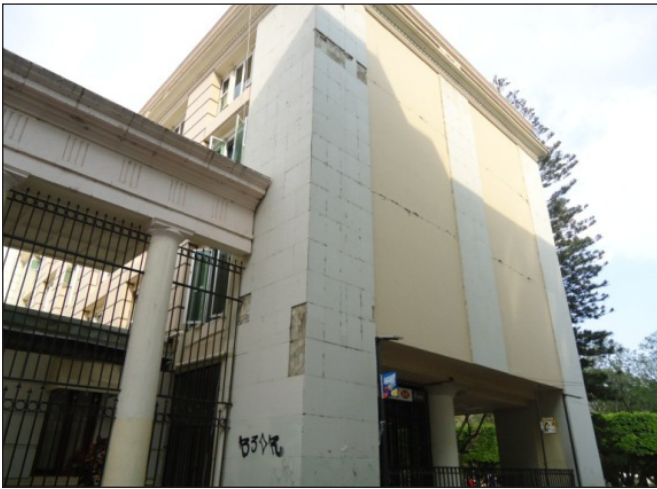
Figure 12. The concrete government building in downtown Chilpancingo was damaged in the December 16th, 2011, earthquake, and the March 20th, 2012, earthquake increased the damage.

In Chilpancingo, Guerrero, geological conditions have significantly amplified the ground motion in past earthquakes (Gómez-Bernal et al., 1999). The March 2012 Ometepec earthquake caused accumulation of damage in some structures. The government building located downtown, a few meters from the Cathedral, is a four-story concrete building with infill masonry walls, and an irregular structural configuration (soft first floor at one end), had moderate nonstructural damage and light structural damage in the concrete columns (Figure 12).

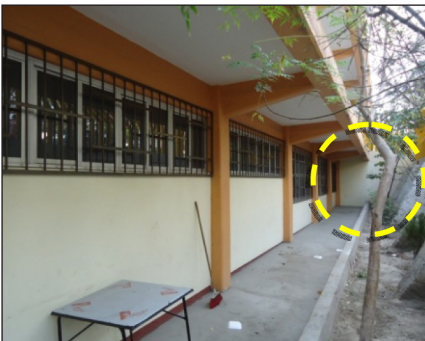
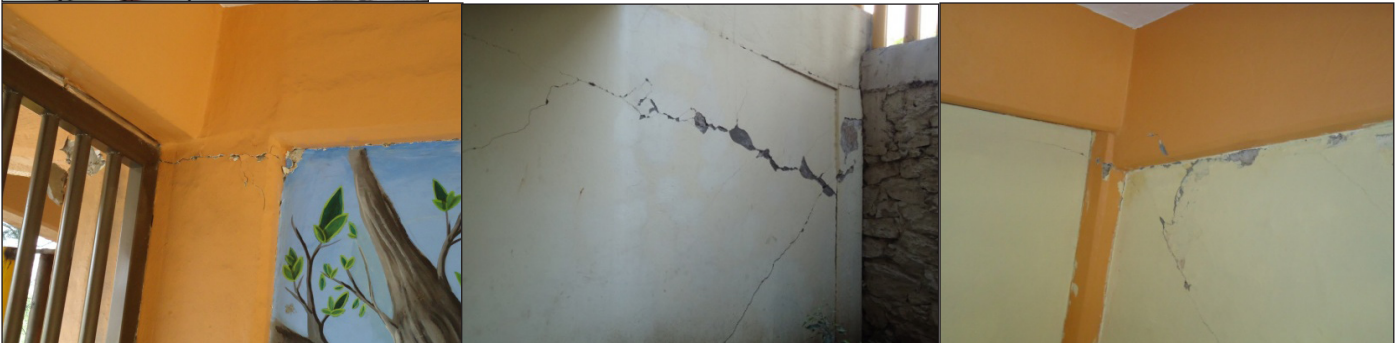
It is a three-story concrete frame structure with masonry infill walls, with a 50 x 15 m plan dimension. The building was restricted on the ground level with a stair entrance, which has two parallel walls in the center (Figure 13). This condition restricted the oscillating movement of the building in the short direction, causing severe structural damage in the ground and first levels.

Figure 13a-d. Structural damage to the first two levels of the building.

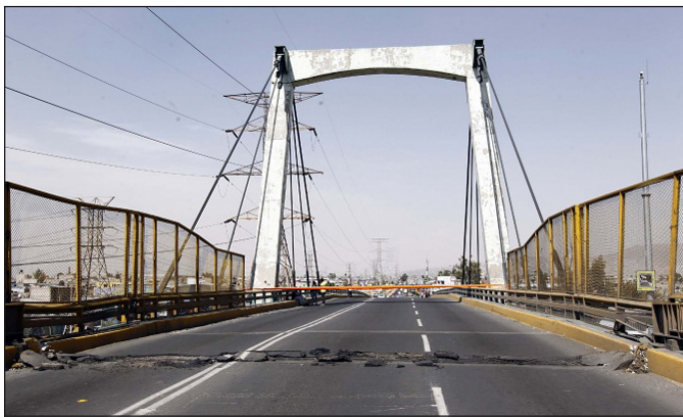
Figure 14a and b. Left: vehicle bridge. Right: collapsed hand rail of a pedestrian bridge.

vehicle bridge caused damage to the deck (Figure 14 left). Part of a pedestrian crossing bridge collapsed in a main street of northern Mexico City (Figure 14 right).
